**SOP M - Post-Remediation Inspection Procedures**
**KING HIGHWAY LANDFILL  
POST-REMEDIATION INSPECTION FORM**

ALLIED PAPER, INC./PORTAGE CREEK/  
KALAMAZOO RIVER SUPERFUND SITE

LANDFILL INSPECTION REPORT

Subject:  
King Highway Landfill OU – 2012 4<sup>th</sup>  
Quarter Landfill Inspection Report

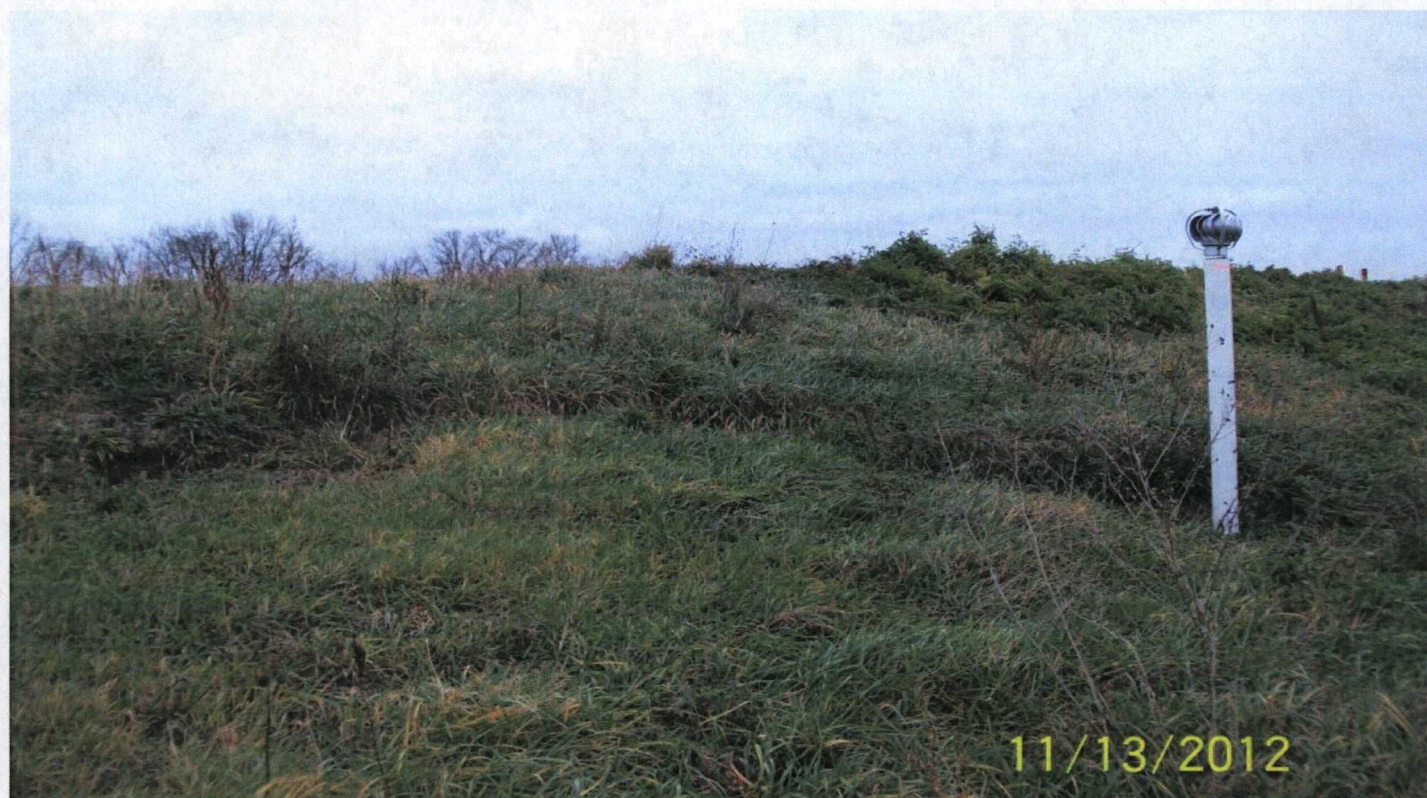
Photo No. 1: This photo shows gas vent V-1-2 and the area of erosion on the slope adjacent to the gas vent.

<b>Ditches and Diversion Berms</b>					
Siltation	X		Remove excessive sediment buildup.		
Debris Buildup	X		Remove debris washed out materials.		
Disturbed Vegetation	X		Reseed areas of lost vegetation.		
Erosion		X	Regrade or place additional appropriate materials in the affected areas and promptly reseed to establish vegetative growth.	A small area of soil on the slope adjacent to gas vent V-1-2 has sloughed down the slope possibly due to water accumulating in the drainage way located along the south side of the landfill. Next spring this area will be brought back to the appropriate elevation by the addition of topsoil within the eroded area. The area will be reseeded and mulched to facilitate vegetative growth and promote soil stability. The drainage way will be regraded to prevent water from accumulating prior to repair of the sloughed area.	1
<b>Culverts</b>					
Siltation	X		Remove excessive sediment buildup.

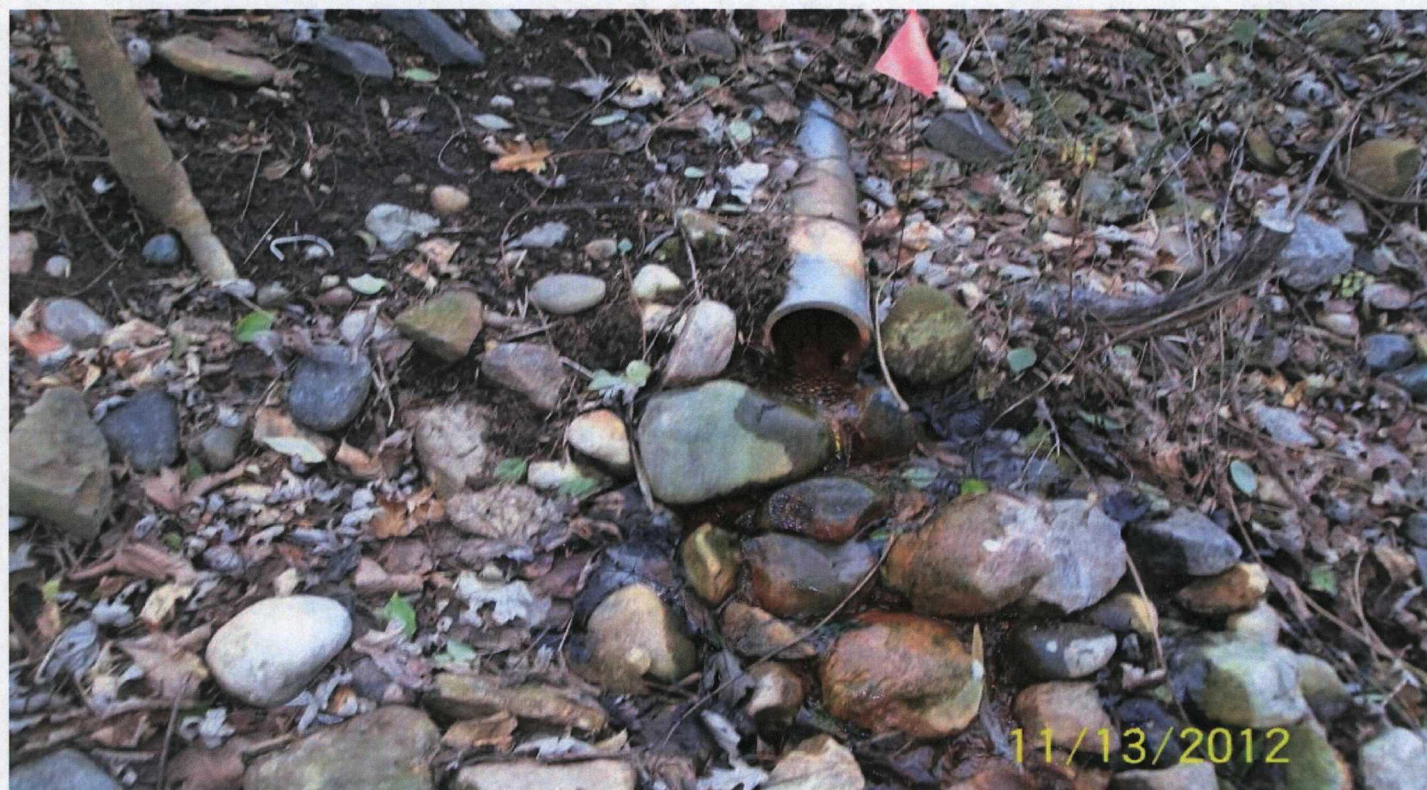
<b>Surface Water and Pore Water Collection System</b>					
Clogging of Outlets	X		Remove any debris or obstructions/blockages obstructing flow through the pipe.	Water was observed to be discharging freely from the north pore water pipe.	2
Evidence of Settlement/Exposed Materials	X		Regrade or place additional appropriate materials in the affected areas and promptly reseed to establish vegetative growth.		
Condition of Inlet/Outlets		X	Replace or repair pipes that have been damaged such that flow is obstructed.	The southern pore water discharge pipe, which was previously extended to the western rip rap apron during the recent final cover system repairs, was observed to be under ponded water. The south pore water pipe will be relocated so that the pipe outlets further up the slope over the area of rip rap over the next several months.	3
<b>Landfill Gas Management System</b>					
Condition of Exterior Vent Pipe Components	X		Replace broken/damage vent pipes. Exposure of geomembrane pipe boot above the ground surface should be noted, as well as any damage to the pipe boot.

Photo No. 2: This photo shows the free flowing water discharging from the north pore water pipe.

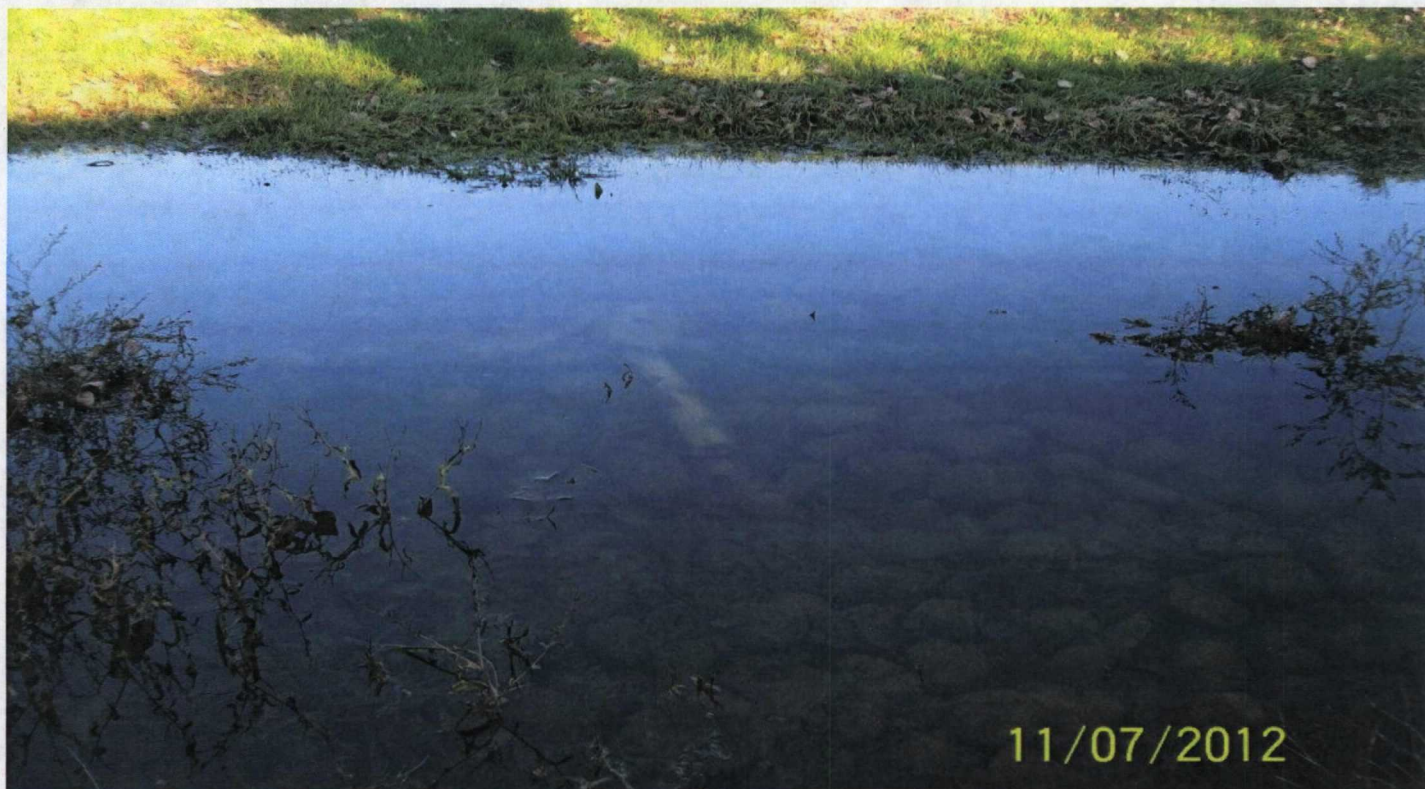
Photo No. 3: Photo shows the south pore water pipe submerged under ponded water in the settling basin near the southwest corner of the KHL.

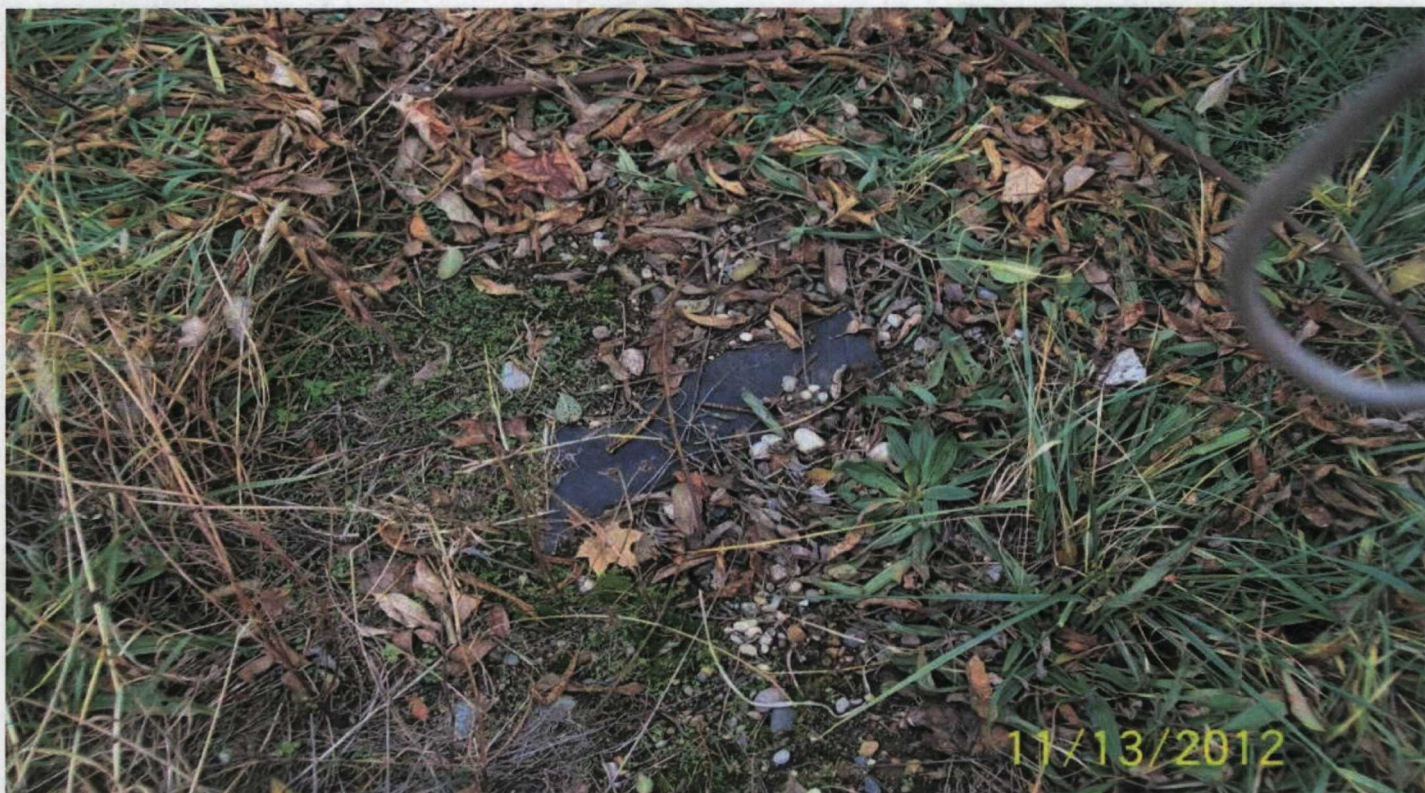
Photo No. 4: This photo shows the area of exposed geosynthetics adjacent to gas vent V-2-3 near the southeast corner of the KHL.

Inspection Items	Condition Satisfactory		Response	Comments/Proposed Action Items	Photo Nos.
	Yes	No			
Cover System					
Settlement	X		Strip the soil, place and compact suitable soils within the depression, and replace excavated soil. Once the proper slope is restored, reseed the disturbed area.		
Water Ponding	X		Strip the soil, place and compact suitable soils within the depression, and replace excavated soil. Once the proper slope is restored, reseed the disturbed area.		
Soil Erosion	X		Regrade or place additional appropriate materials in affected areas and promptly reseed to establish vegetative growth.		
Slope Movement/ Failure	X		Regrade or place additional appropriate materials in affected areas and promptly reseed to establish vegetative growth.		
Exposed FML		X	Regrade or place additional appropriate materials in affected areas and promptly reseed to establish vegetative growth.	A small 6-inch by 12-inch area of exposed geosynthetics was observed near gas vent V-2-3. Next spring this area of exposed geosynthetics will be covered with fill and topsoil and the area seeded and mulched to facilitate vegetative growth.	4
